# Manhole Inspection Summary

Manhole # S25GG1031MH

Insp Date: **1/17/07 1:41 PM**

**Location** Address: **1020 41ST ST**

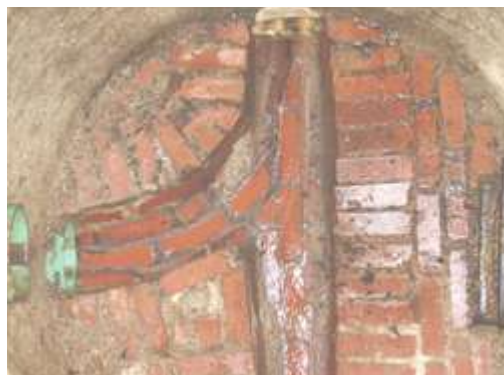
Top View

☒ **Debris** (not Condition related)

Bench debris.

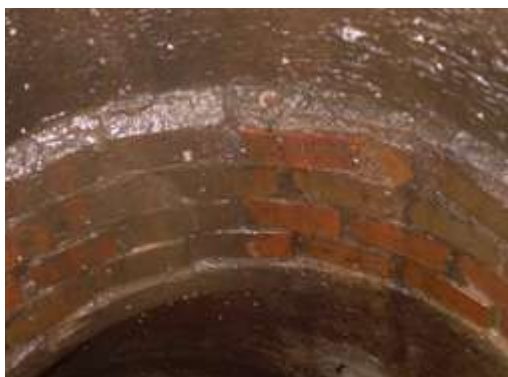
Defect

☒ **Leaks**

Infiltration: ☐ None ☒ **Joint** ☐ Cracks ☐ Mortar ☐ Roots ☐ Wall

Frame leaks. Adjustment infiltration.

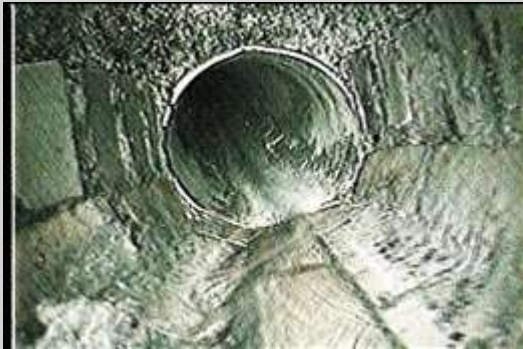
### 8 in. Circular Gravity Sewer Pipe Out @ 12 O'Clock

Comments **The O12 pipe picture shows Channel deterioration.**

Condition: ☐ Sound ☐ Cracked ☐ Root Intrusion ☒ **Deteriorated** ☐ Leaks ☐ Debris

Deposits: ☐ None ☐ Mud ☐ Sludge ☐ Debris ☒ Grease

Silt Depth: **0** (in.) Deposits Extent: **Light**

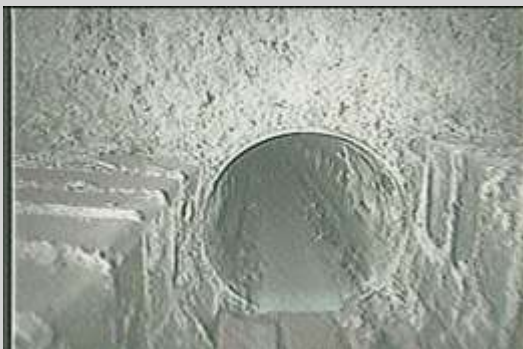
### 8 in. Circular Gravity Sewer Pipe In @ 6 O'Clock

Deposits: ☐ None ☐ Mud ☐ Sludge ☐ Debris ☒ Grease

Silt Depth: **0** (in.) Deposits Extent: **Light**
